Structural and non-structural water management concepts and community participation in managing land and water resources in ancient Sri Lanka

Chandima Gunasena

Present paper discusses four cases to illustrate the present status of the hydrological controls adopted in Rnamasu Uyana, Segiriya lion rock area, Polonnaruwa ruin city and Udawaththa forest reserve in Kandy.

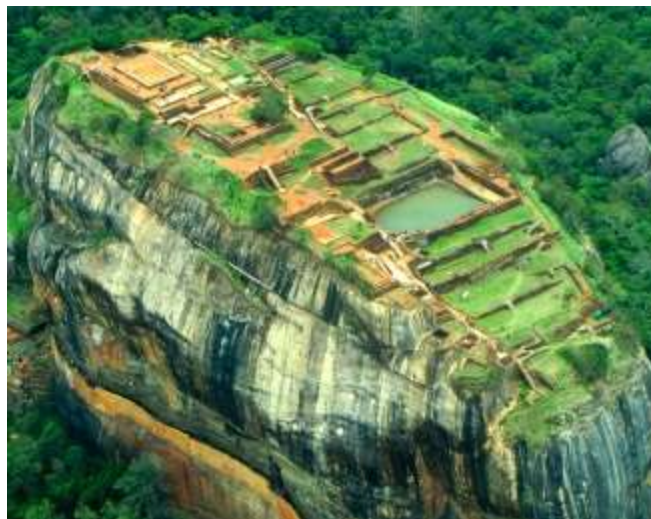
At the top of the rock, a water pond has been created and that is to collect rain water receives to the top of the rock. Land is graded to drain water to this pond and just above the bottom of the pond and a drainage outlet could be seen.

Figure 1: Top most pond on the top of the Segiriya lion rock

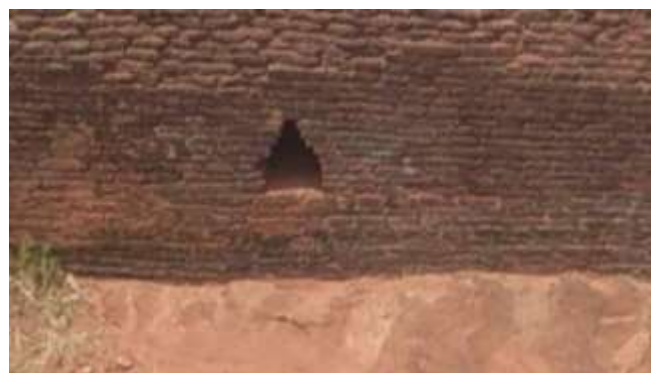
Figure 2: Drainage outlet of the top most Pond

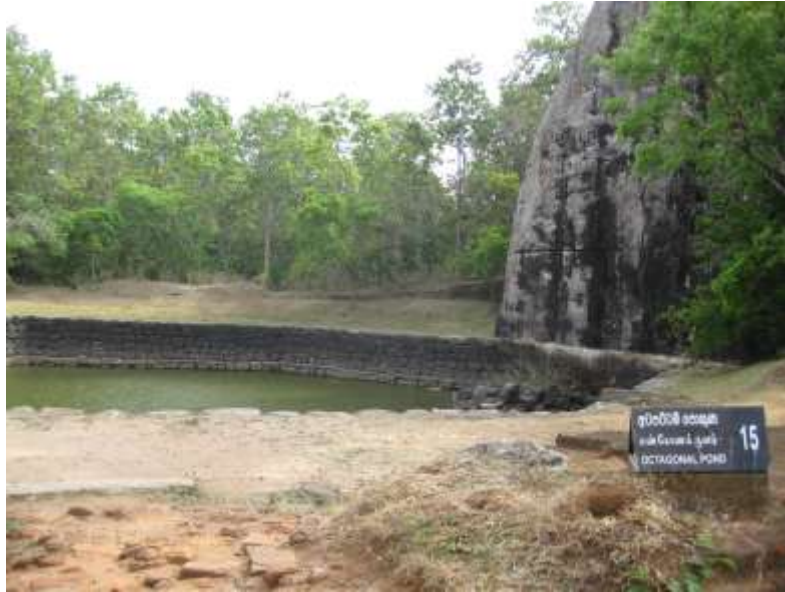
Most of the water receives from rain storms to the rock are collected to the octagonal pond "Atapattam Pokuna".

Figure 3: Octagonal pond

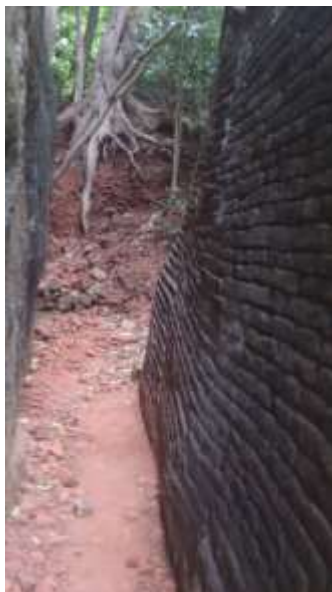
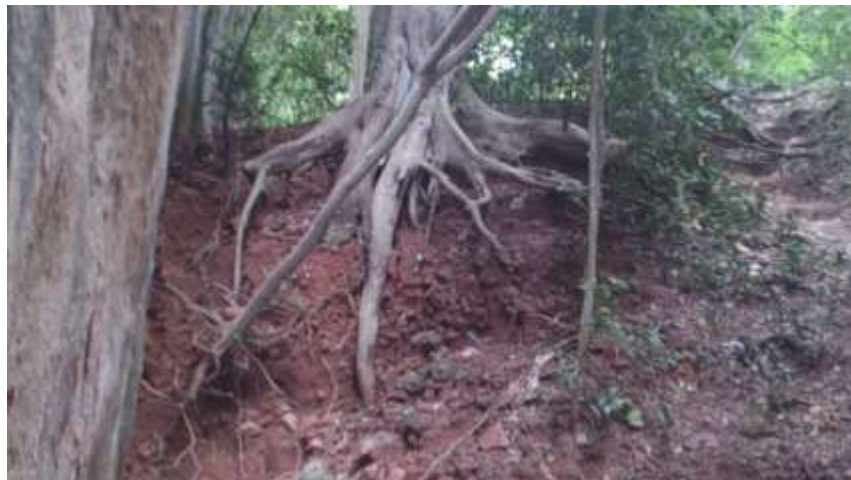
Figure 4 (a) shows the pathway of the water coming down from the upper landscape towards the octagonal pond and this should be covered with vegetation but now it is cleared without knowing the function of the vegetation cover. Vegetation cover helps to filter debris and slow down the velocity and promote infiltration which again flourishes the ground water. Figure 4 (b) shows the upper landscape and the flow path and that area was also cleared to build a foot path. Here structural drainage pipes were not used to drain water instead nonstructural drainage systems were used.

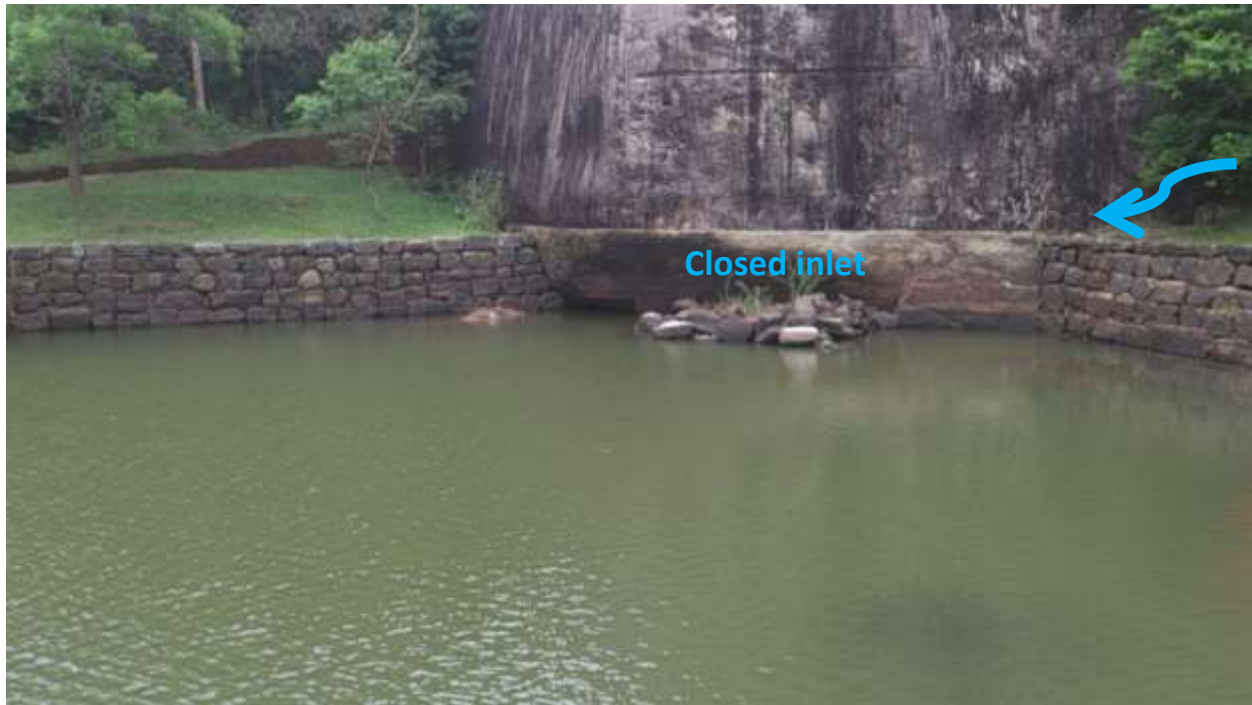
Figure 5: Inlet of the Octagonal pond

Perhaps inlet is closed with rocks and soil to stop the muddy water coming in to the pond during the rainy season.

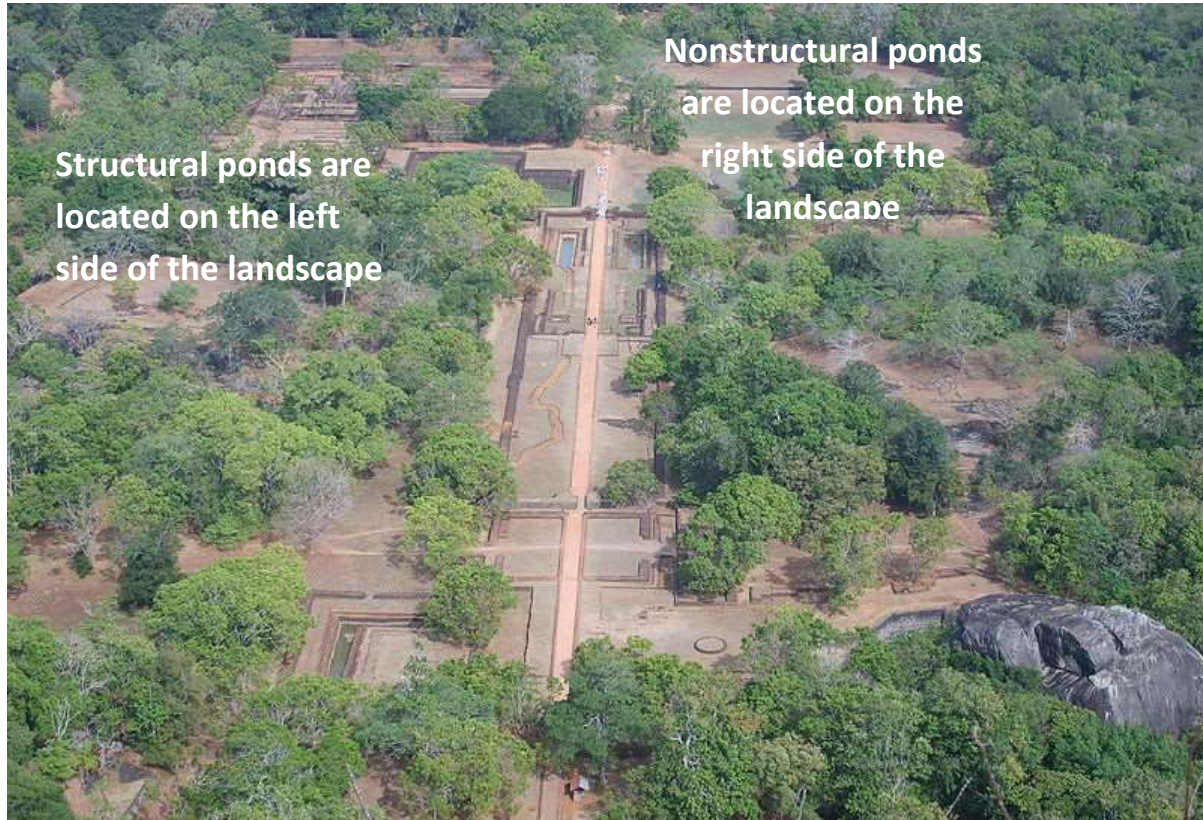
Rock is at a fairly higher ground and rainwater receives to this land area is collected to structural ponds as well as nonstructural depression areas.

Figure 6: Arrangement of structural and nonstructural ponds

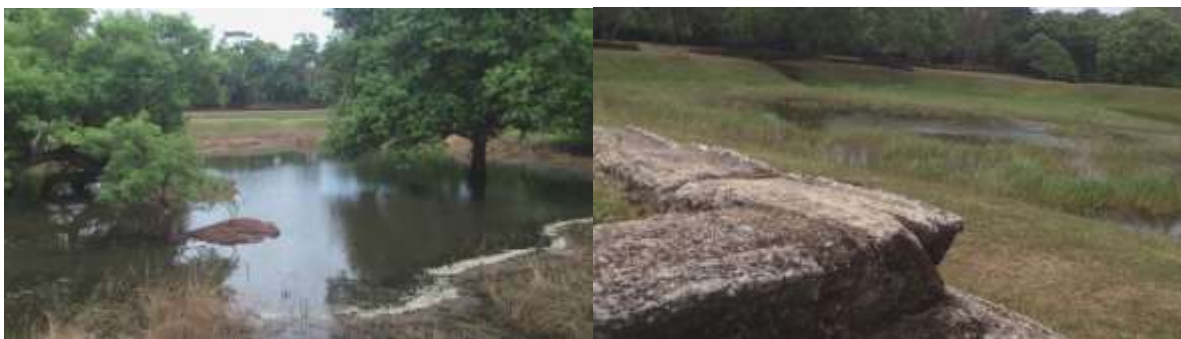
Figure 7: Degrading nonstructural ponds

These structural and nonstructural ponds may be connected through underground drainage lines or surface drainage systems. Nonstructural ponds are getting silt loads from each rainy season due to lack of maintenance of the landscape as hydraulic control structures designed for rainwater harvesting.

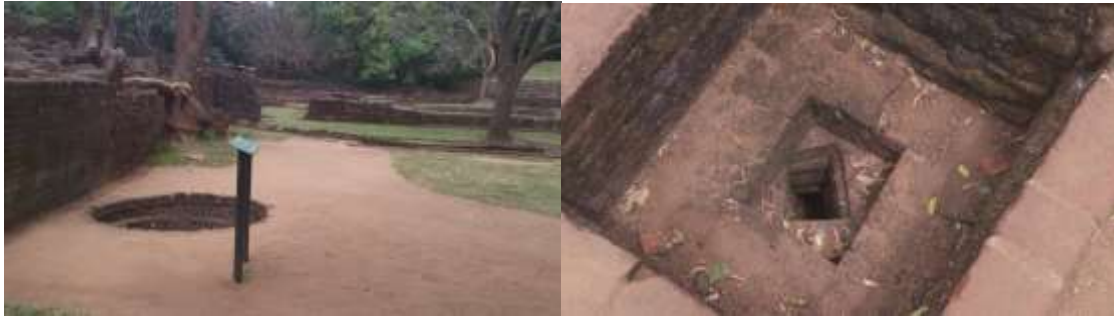
Figure 8: Openings for underground drainage systems

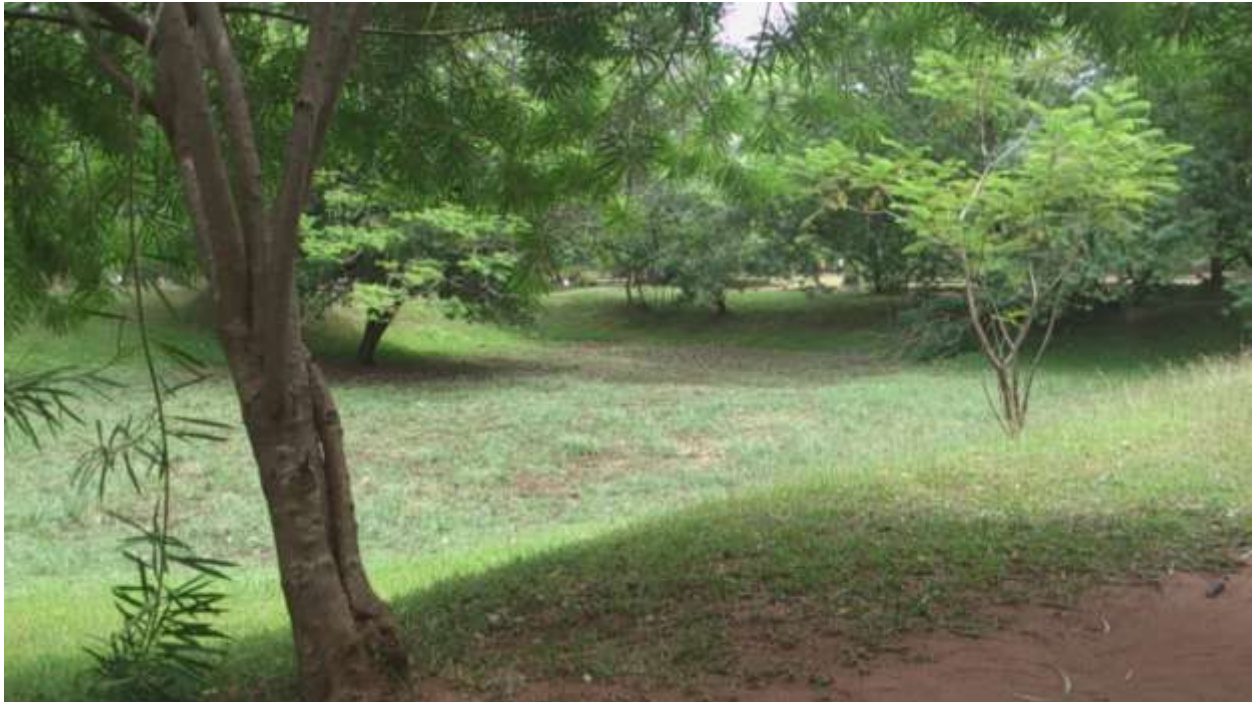
Figure 9: Nonstructural depression areas and drainage patterns

As shown in the Figure 9, nonstructural depression areas and drainage patterns are used to direct rainwater to ponds located in lower elevations. During the delivery water is filtered and velocity is reduced to stop any soil erosion. Surface flow paths may have created to increase the distance or naturally existed flow paths may have used to increase the time of concentration to help the infiltration and to flourish the groundwater.

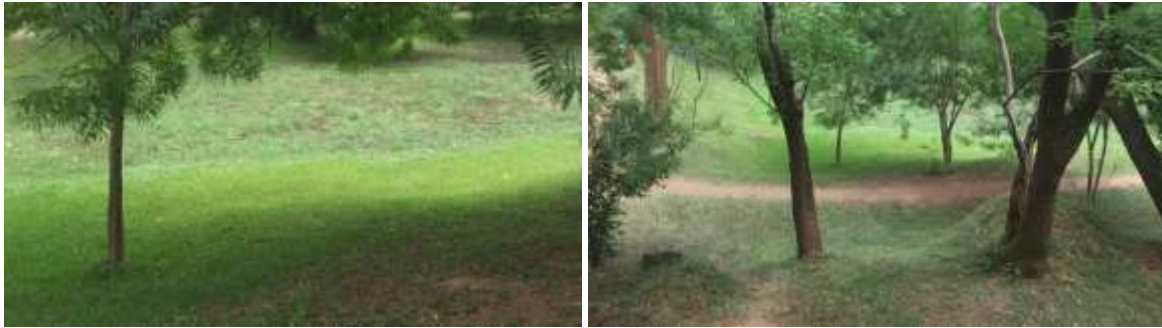
Velocity of water is controlled by providing grass covered land areas with mild slopes to increase the flow path and the time of concentration Figure 10.

Figure 10: Grass covered sloppy areas

Figure 10 shows the connected grass covered sloppy areas with the earthen canals with grass cover. These hydrologic controls help to slow down the runoff water and increase the infiltration and the time of concentration. Artistically carved steps on the rock were used to slow down the water velocity. Those are appeared as water falls during the rainy season Figure 11.

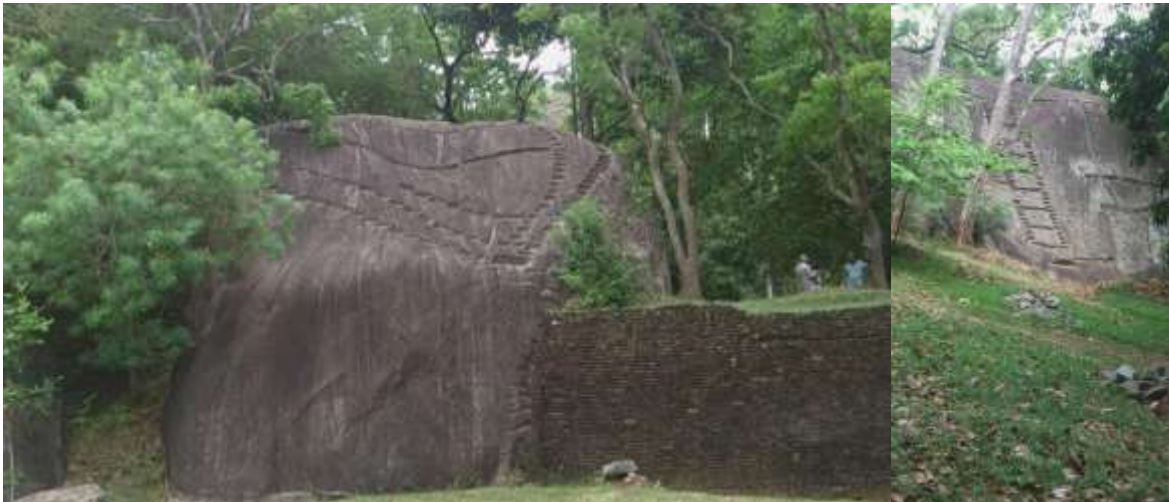
Figure 11: Steps carved in rocks

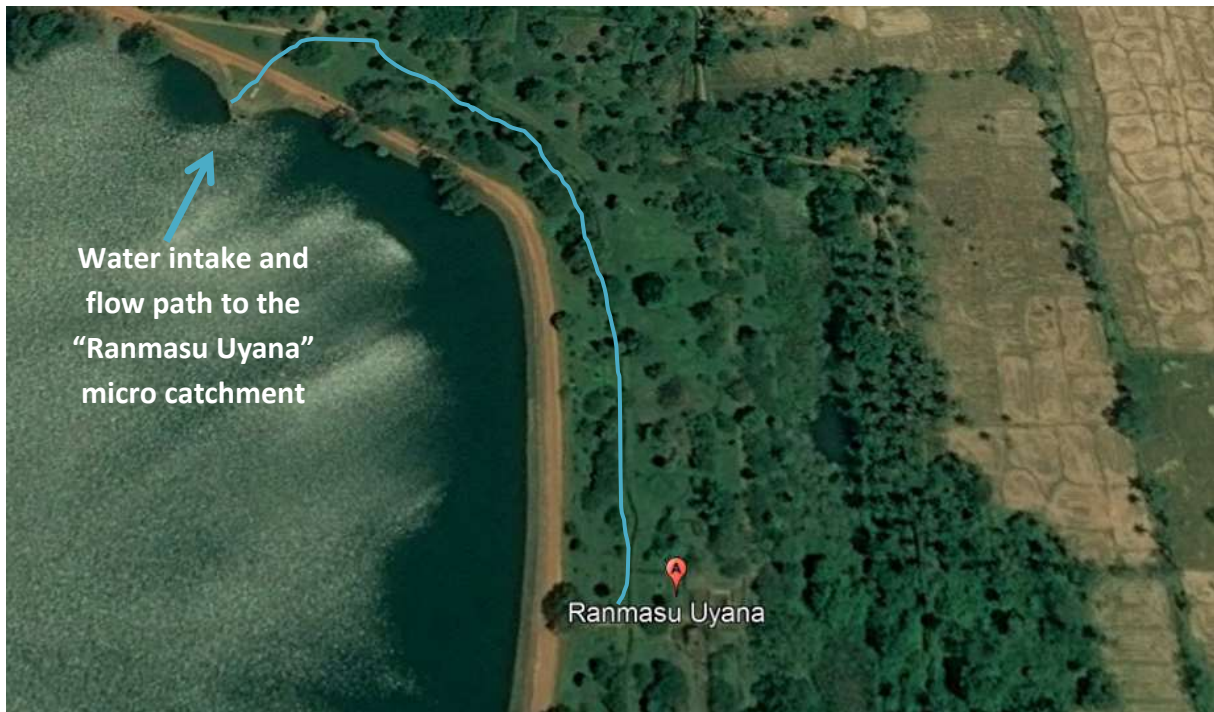
Figure 12: Water intake and the flow path to the “Ranmasu Uyana” from the Thisawewa

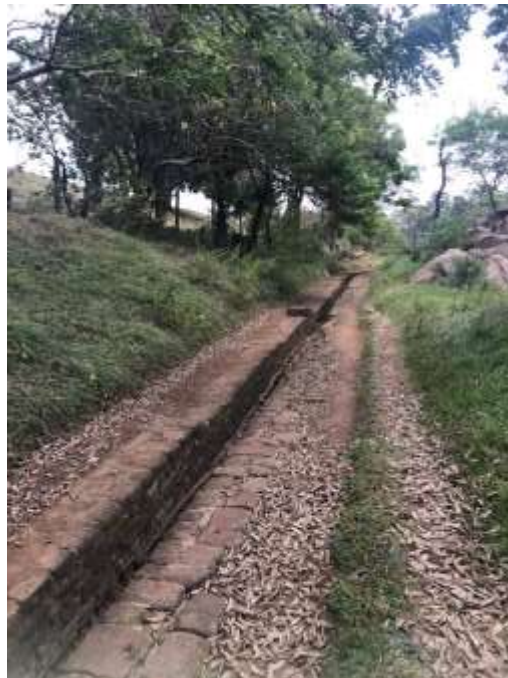
Figure 13: Structural drainage canal system which carries water from “Thisawewa” to the “Ranmasu Uyana” micro catchment.

As shown in the Figure 13, water reaches to several structural ponds in the “Ranmasu Uyana” micro catchment and along the flow path several desilting facilities could be observed Figure 14.

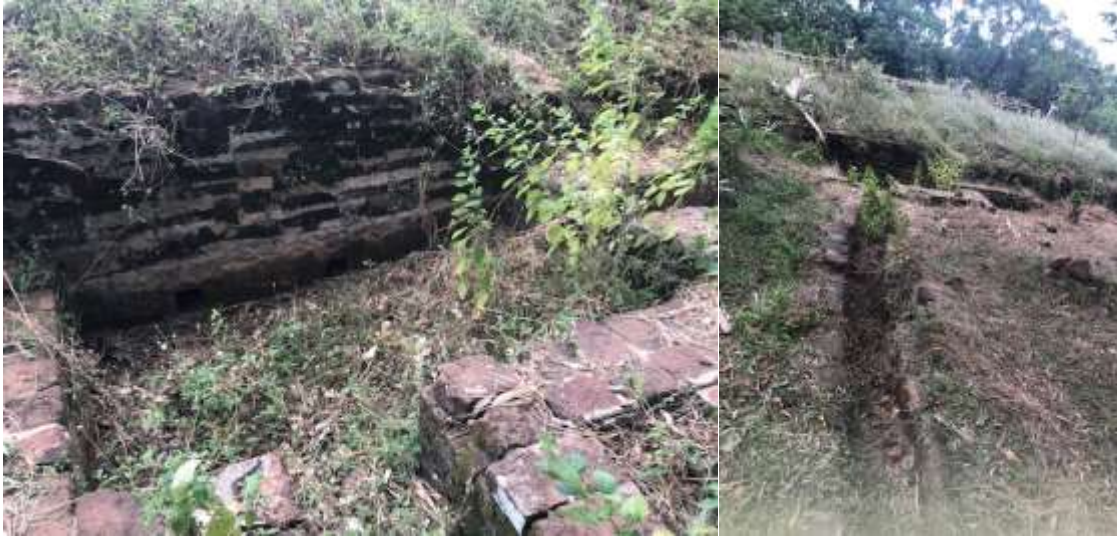
Figure 14: Desilting facilities

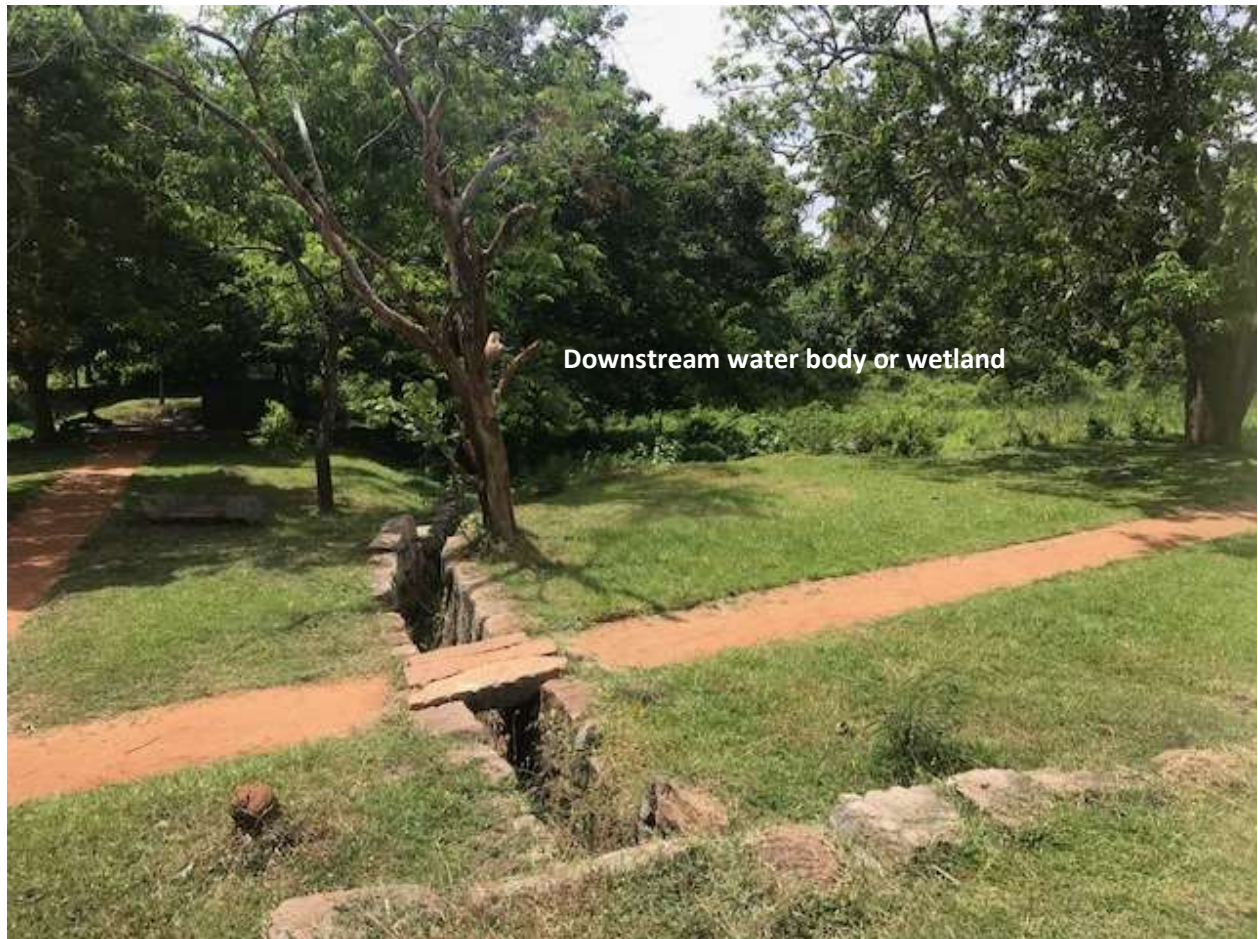
Figure 16: Drainage line of bathing ponds towards the downstream wetland

Figure 16 shows the drainage line running from bathing ponds towards the downstream area where series of wetlands or another nonstructural water bodies are present. Presently these ponds are not fed by the “Thisawewa” any more and therefore these series of wetlands or ponds are not getting enough water and gradual eutrophication and siltation is taking place.

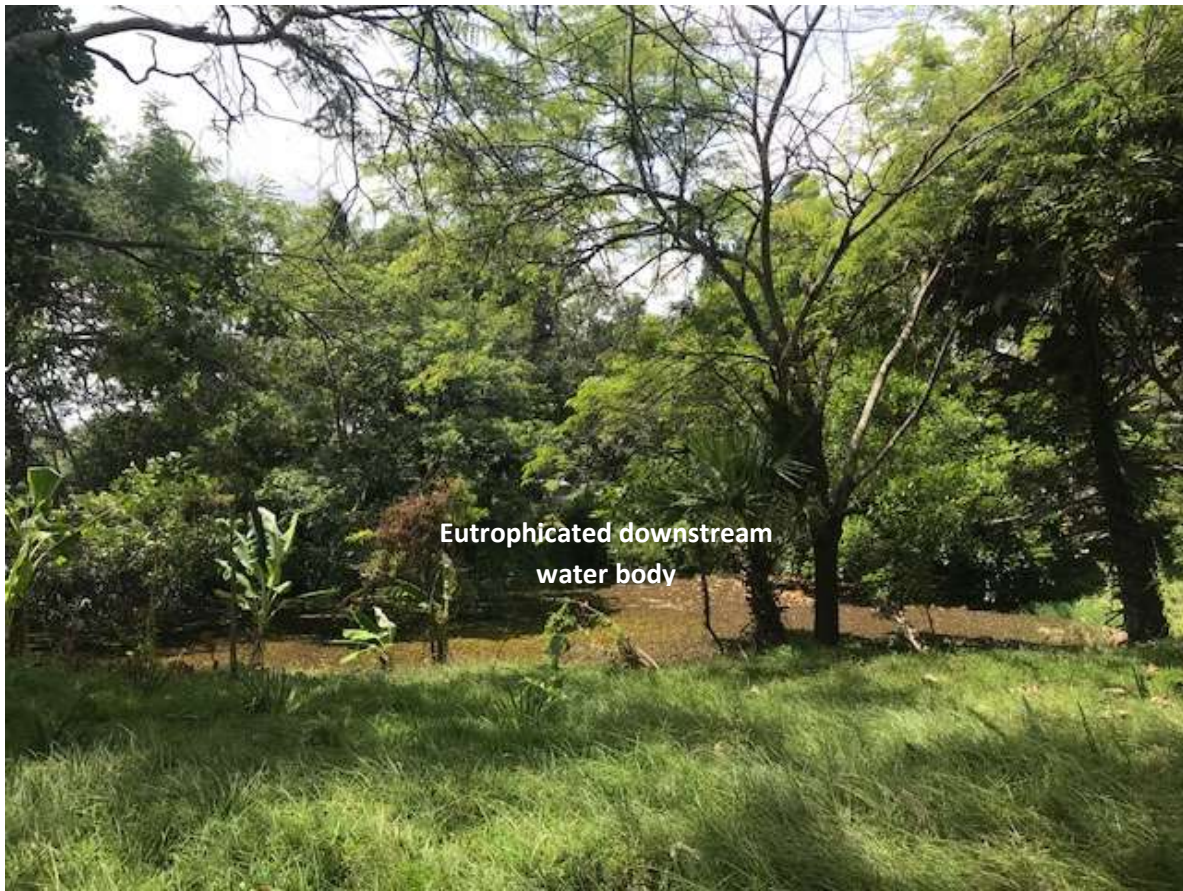
Figure 17: Eutrophication taking place in nonstructural ponds

As shown in the Figure 17 these series of wetlands running towards downstream paddy lands are degrading due to eutrophication and silting.

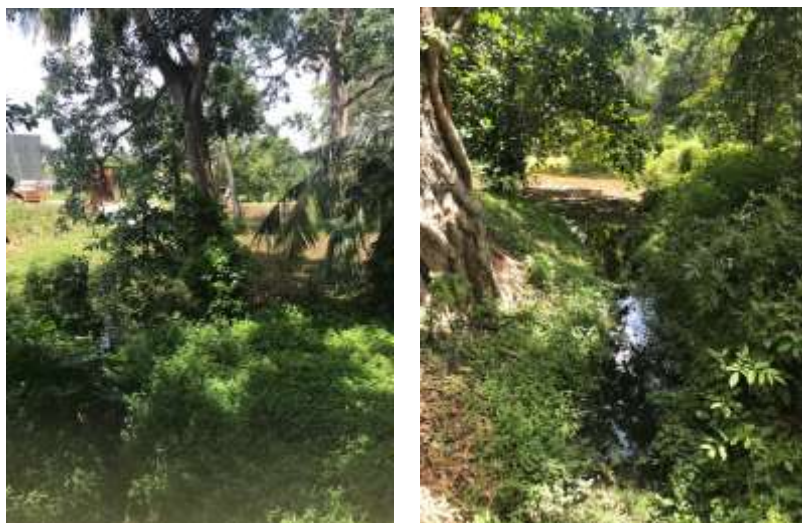
Figure 18: Drainage outlet of the “Ranmasu Uyana” micro catchment

Water taken from the “Thisawewa” is taken for bathing purposes and finally goes through a series of wetlands and ponds before entering in to the paddy field area. Water use efficiency is maximized with these hydrological control systems and provides cooling and aesthetically pleasing environment for the King as well as purification of used waters.

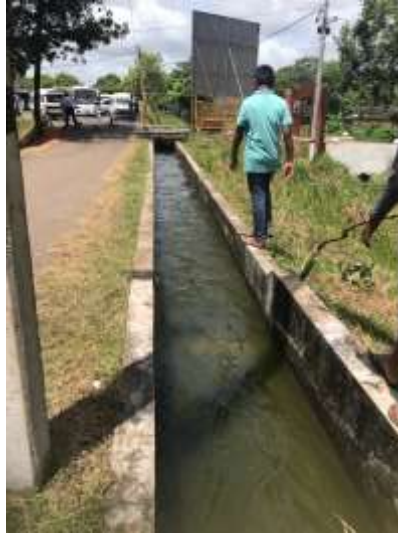
Figure 19: Concrete lined canal at the downstream of the “Ranmasu Uyana”

Presently, a concrete lined canal has created to take water to the downstream paddy lands and ancient sustainable irrigation system is abandoned. This will seriously affects the long term sustainability of above mentioned series of interconnected wetlands and ponds.

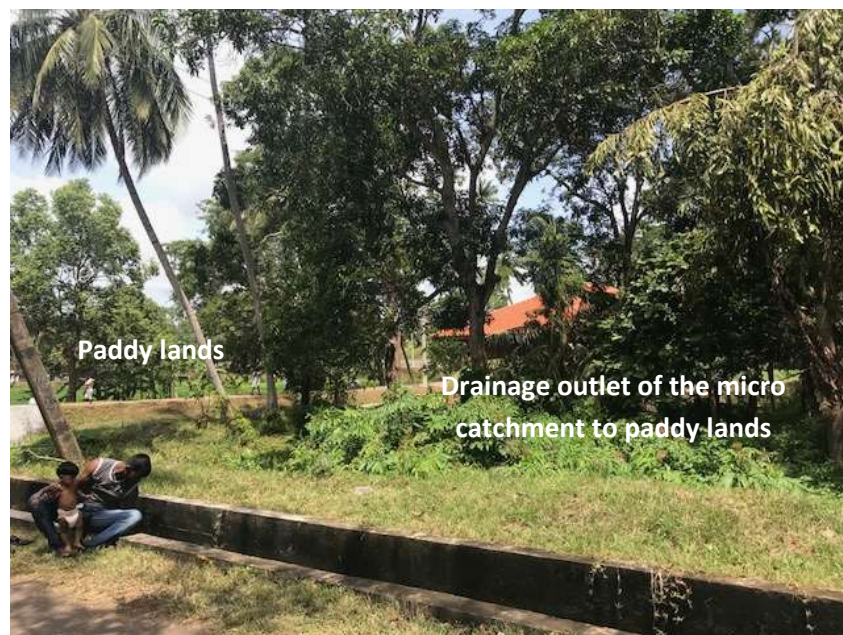
Figure 20: Natural drainage outlet and manmade concrete lined canal

Natural drainage outlet of the micro catchment is blocked and road is constructed to provide transport facilities. Therefore, natural drainage system is not functioning and silting and eutrophication is aggravated in wetlands and ponds in upper catchment areas Figure 20.

It is a must to reestablish the abandoning irrigation network in this area to safeguard the natural hydrological process which was preserved for many thousand years.

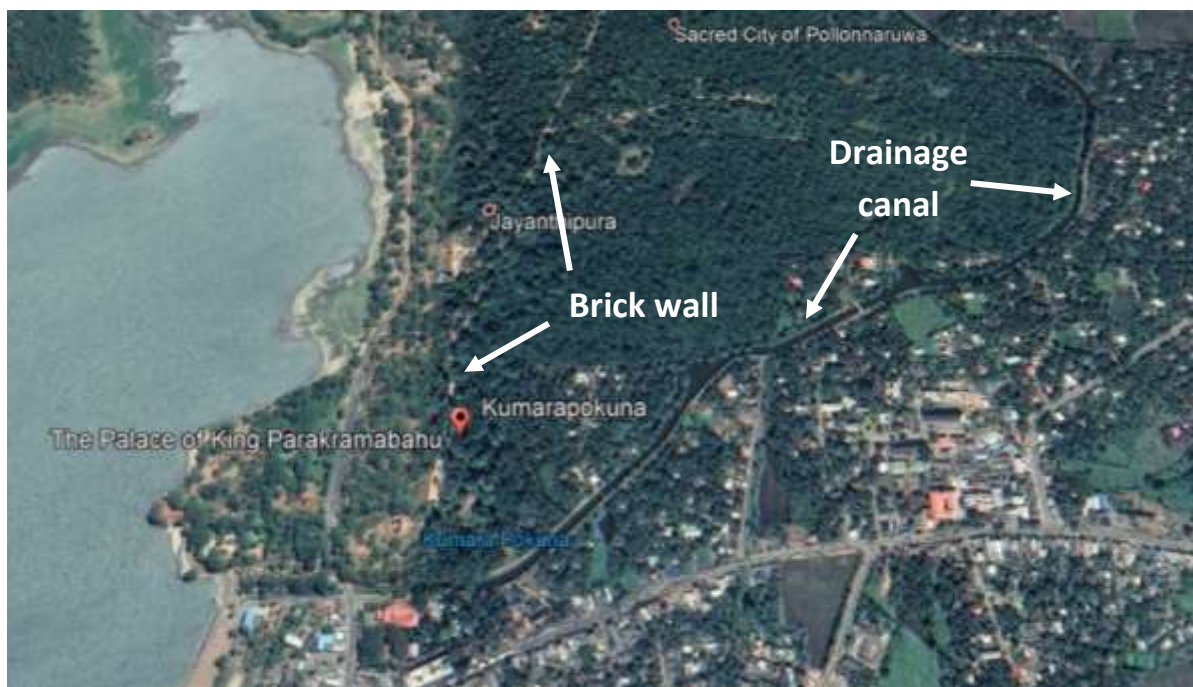
Figure 21: Kings palace, :Parakramabahu Samudraya” reservoir

Palace is situated near the “Parakrama Samudraya” and from the reservoir side and covered by a large brick wall. Eastern side of the palace is demarcated with an irrigation canal. Entire landscape is sloping towards the canal side and entire landscape is designed to harvest the rainfall receives.

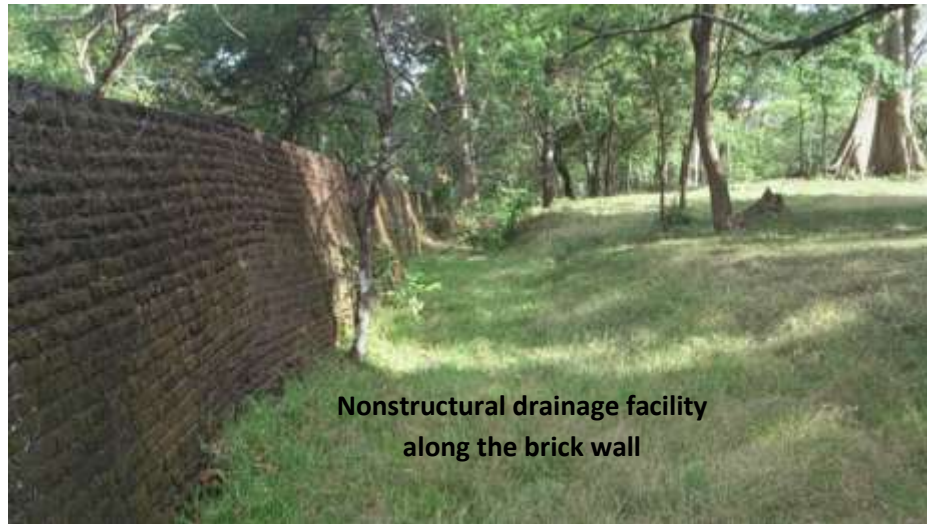
Figure 22: outer brick wall and nonstructural drainage facility

As shown in the Figure 22, nonstructural drainage facility has provided to store runoff water temporarily. This will also increase the flow path and the time of concentration and facilitate infiltration and thereby replenishes the ground water.

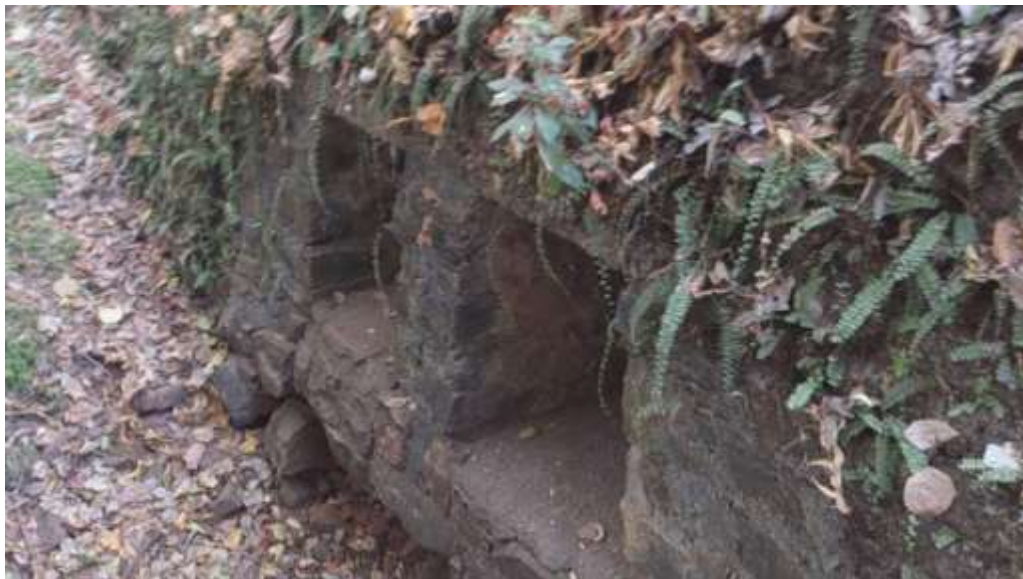
Figure 23: Structural sluice gates in the brick wall

Structural sluice gates are provided in several points of the brick wall and now some of them are closed purposely. This will alter the hydrology of the entire area and will have adverse effects over the natural ecosystem in the long run.

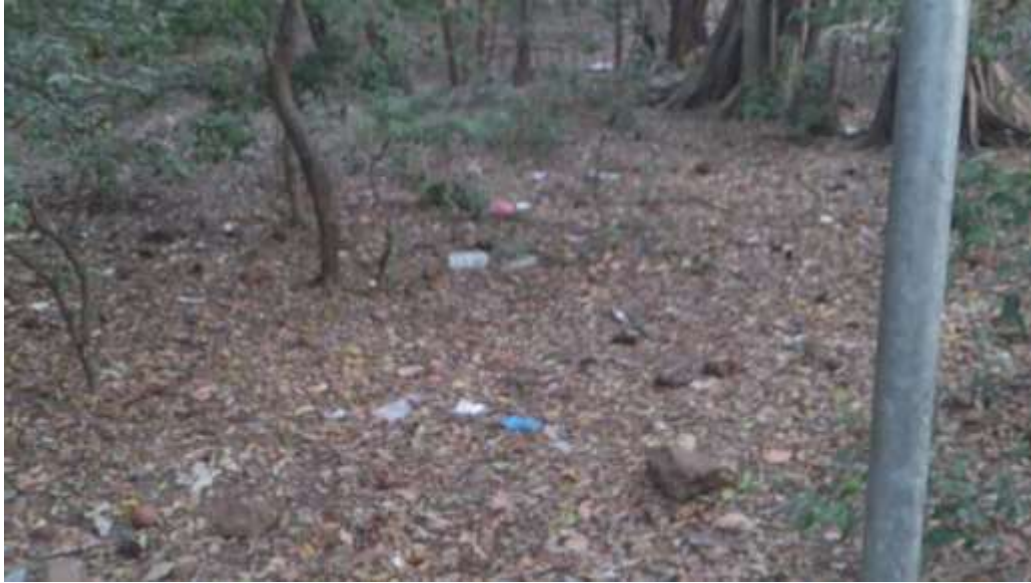
Figure 24: Plastic pollution

Unfortunately, plastic pollution could be seen in the area towards the canal side Figure 24.

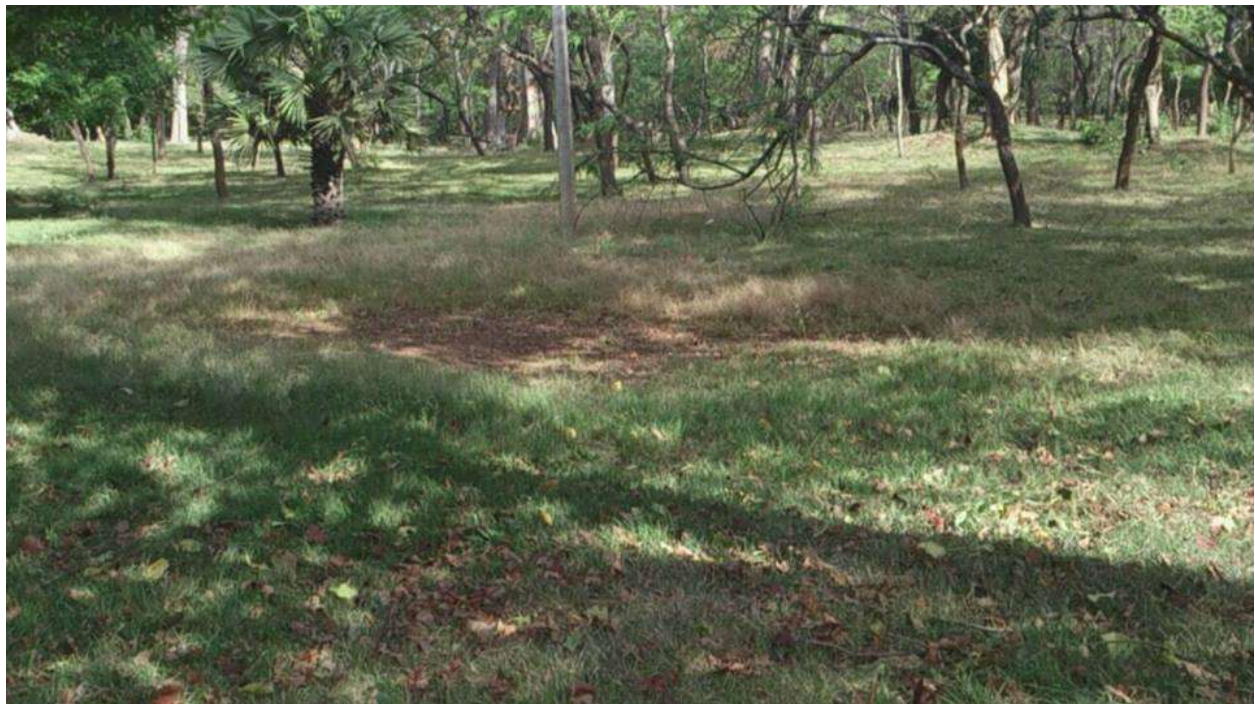
Like Anuradhapura open land areas are not leveled and used to trap Rainwater in depressions and nonstructural drainage systems were used to carry surface runoff water towards the . Runoff Water velocity, has controlled using these depression storage facilities. Ground covet filters silt and derbies

Figure 25: Natural landscape with temporary ponding facilities and nonstructural drainage systems

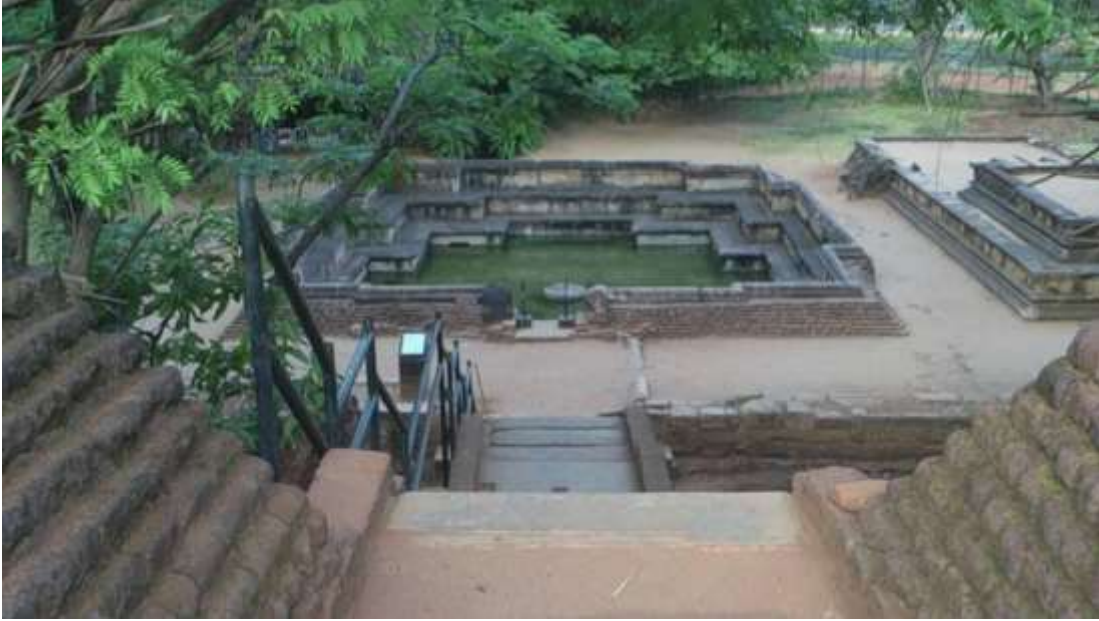
Figure 26: Kumara pokuna at the Kong's palace

Even today “Kumara Pokuna” has purified water Figure 26. But maintenance is carried out without giving priority to the hydrological control structures and therefore, these ponds are not functioning properly. Algal blooms and siltation of temporary ponding areas and nonstructural drainage system could be observed.

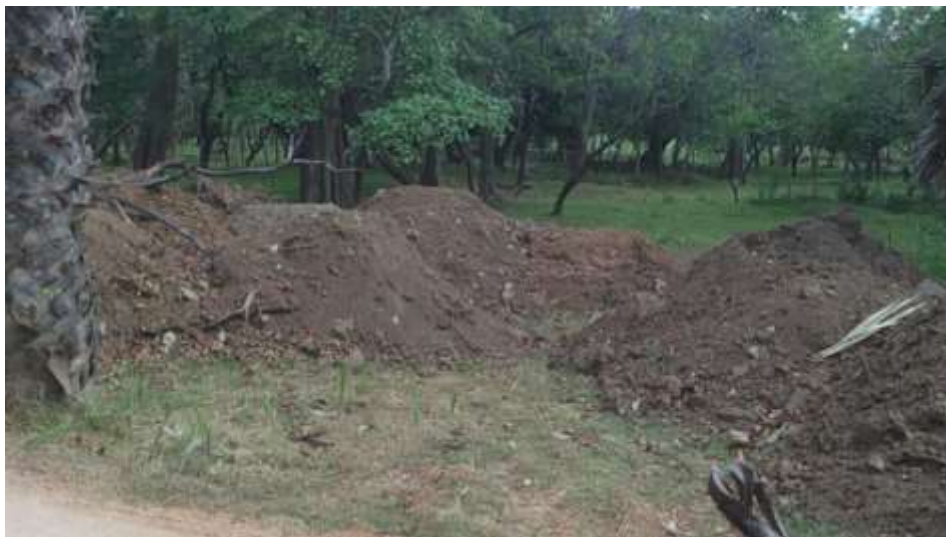
With or without permission from the archeology department soils have been brought to this area may be to level the ground to avoid the depressions. If it is leveled these depressions will be vanished from the area and rainwater will quickly wash towards downstream areas. Further siltation could lead to block of drainage structure and reduce the infiltration process.

Figure 27: Depression storage areas about to be leveled

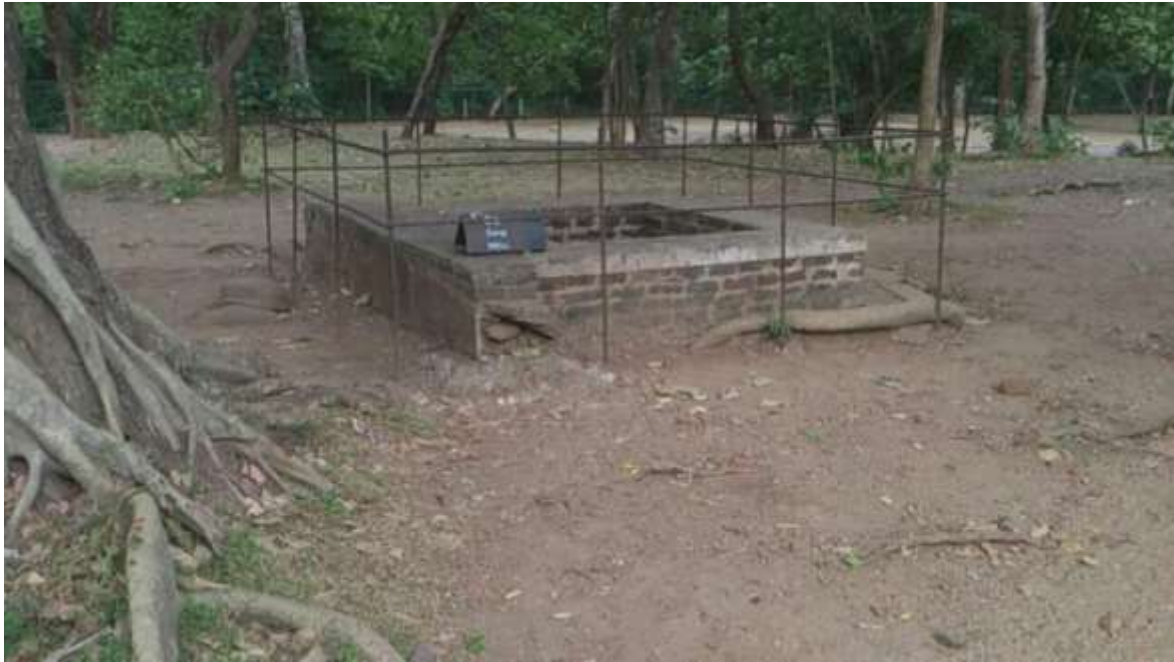
Dug well Figure 28, in the site is 100 or 150 Meters away from the Parakrama Samudraya. Today it is dry. If groundwater seepage provides water to this well, water should be available even today. Definitely underground tunnel must exist from the reservoir. Perhaps now it is closed. If this well has water entire area will receive enough soil moisture to grow vegetation. Neglecting such hydrological controls will have long term environmental impacts to the ecological systems in the area.

Figure 28: Dug well

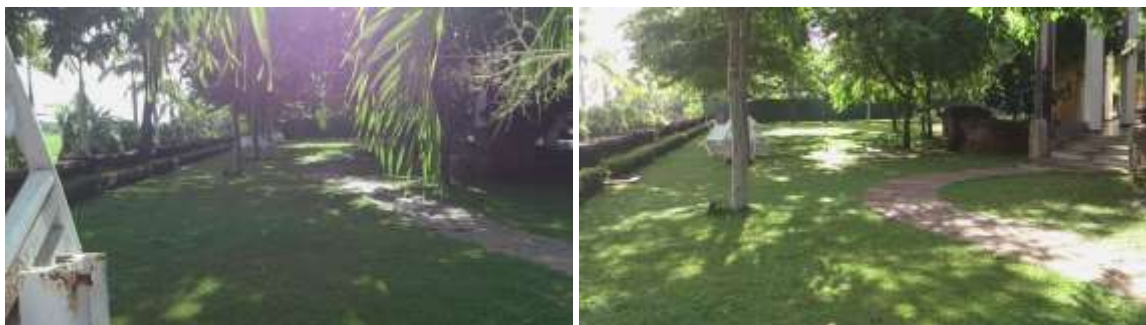
Even though archeology department is safeguarding the structural monuments, has no clear idea about maintaining the hydrological controls used by the King to protect water and to safeguard the entire ecological systems. In the long run entire ecological system could fail due to negligence of these hydrological and ecological factors. Figure 29 shows the modern landscaping approach in polonnaruwa. Land grading is done and land was flattened to achieve the beauty. No space provided for depression storages and rainwater harvesting was not identified to maintain the pre development hydrological standards.

Figure 29: Modern landscaping in Polonnaruwa

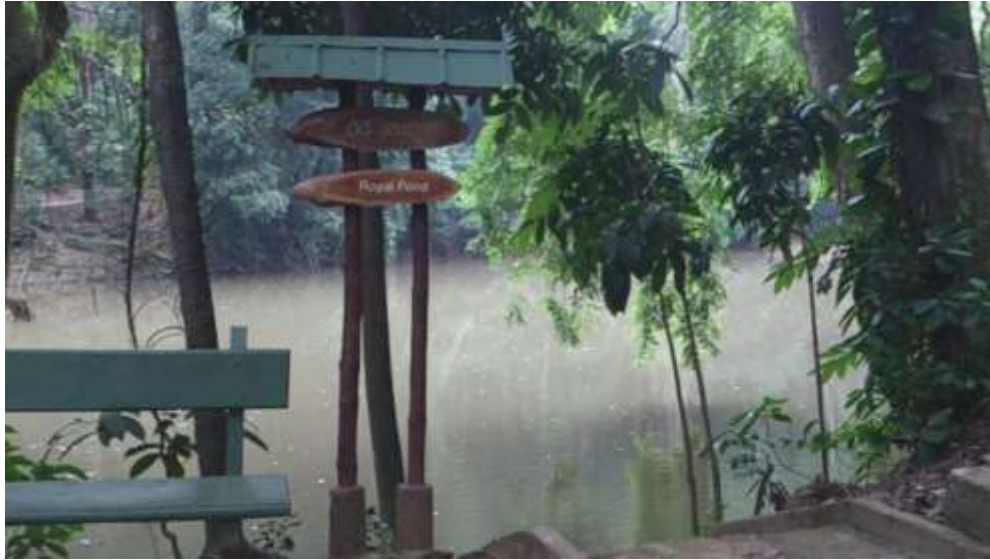
Figure 31: Present status of the Royal pond

Even though the pond has been used for bathing, now water quality has been severely degraded due to siltation and eutrophication.

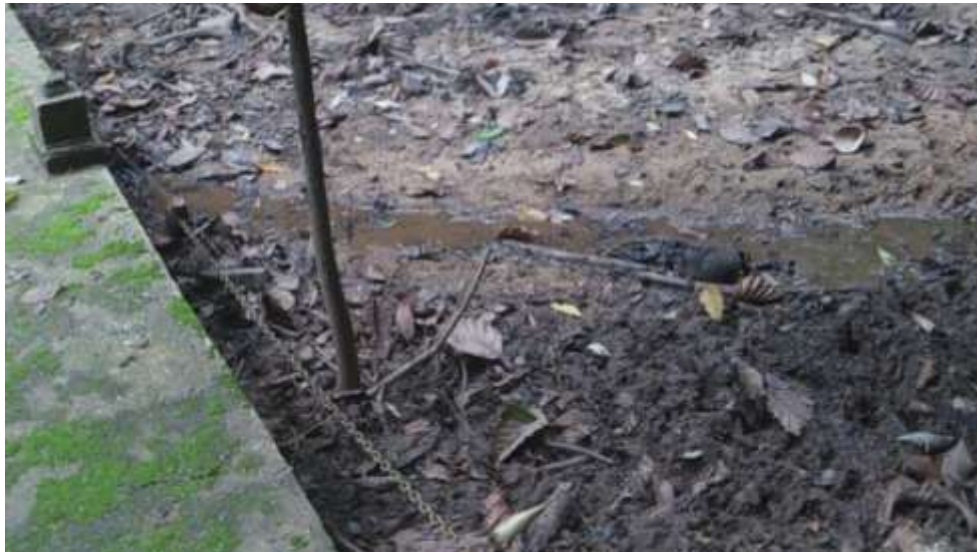
Figure 32: Thalweg line of the stream connected to the royal pond

A stream could be observed coming towards the royal pond from a micro catchment in the forest reserve. Due to heavy siltation stream area is mostly silted and base flow could be observed during the beginning of the July 2018. Kandy experienced heavy rainfall during previous months. But now only a weak base flow could be observed. Soil mass of the forest reserve may not have enough soil moisture to feed the stream during dry periods.

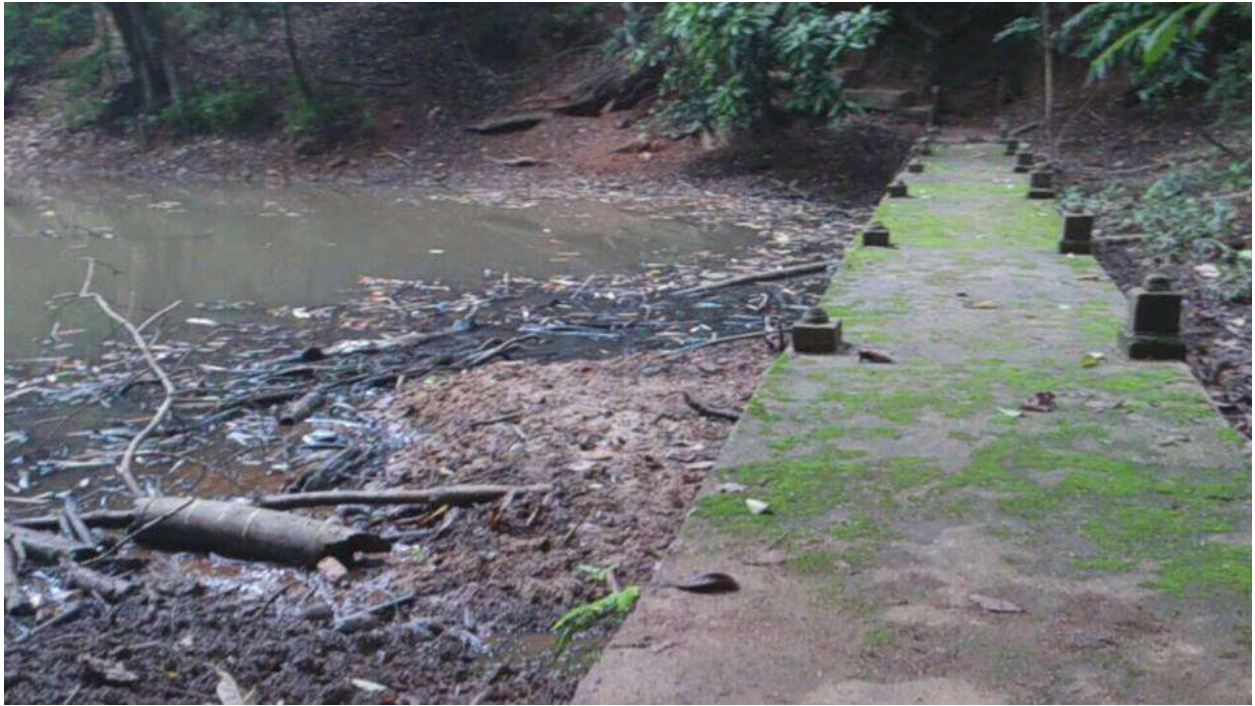
Figure 33 shows the part of the small bridge constructed accord the stream. Lots of derbies and silts are accumulated at the either side of the bridge.

Figure 33: Debris accumulated along the bridge crossing the stream and area is heavily silted

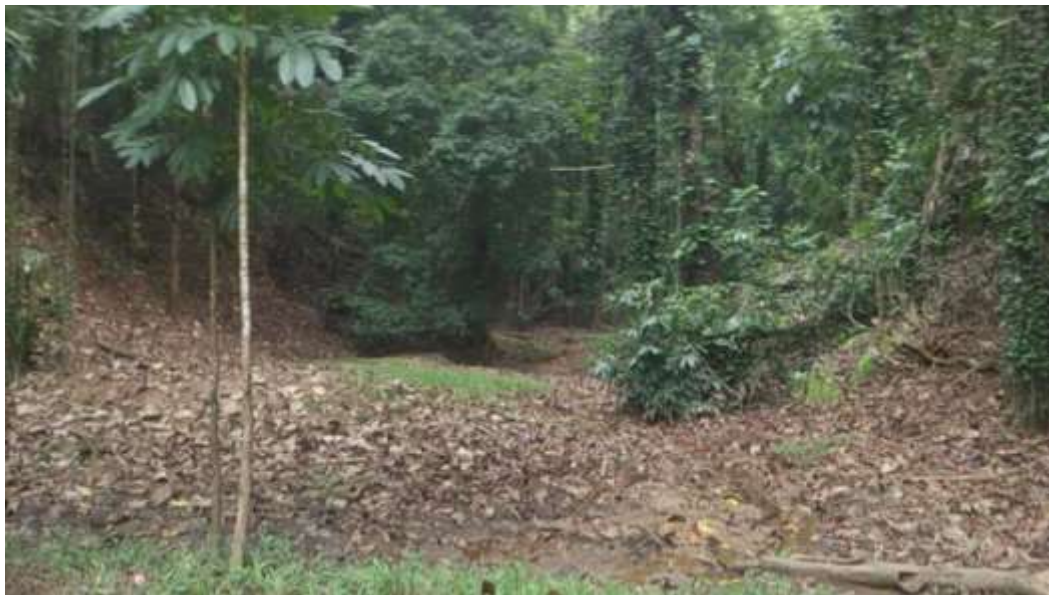
Figure 34 shows the view of upper catchment area from the bridge and that area is not covered with the enough vegetation to control the runoff water velocity and filter the debris and silts coming along.

Figure 34: Silted upstream of the royal pond
