Structural and non-structural water management concepts and community participation in managing land and water resources in ancient Sri Lanka

Chandima Gunasena

Present paper discusses four cases to illustrate the present status of the hydrological controls adopted in Rnamasu Uyana, Segiriya lion rock area, Polonnaruwa ruin city and Udawaththa forest reserve in Kandy.

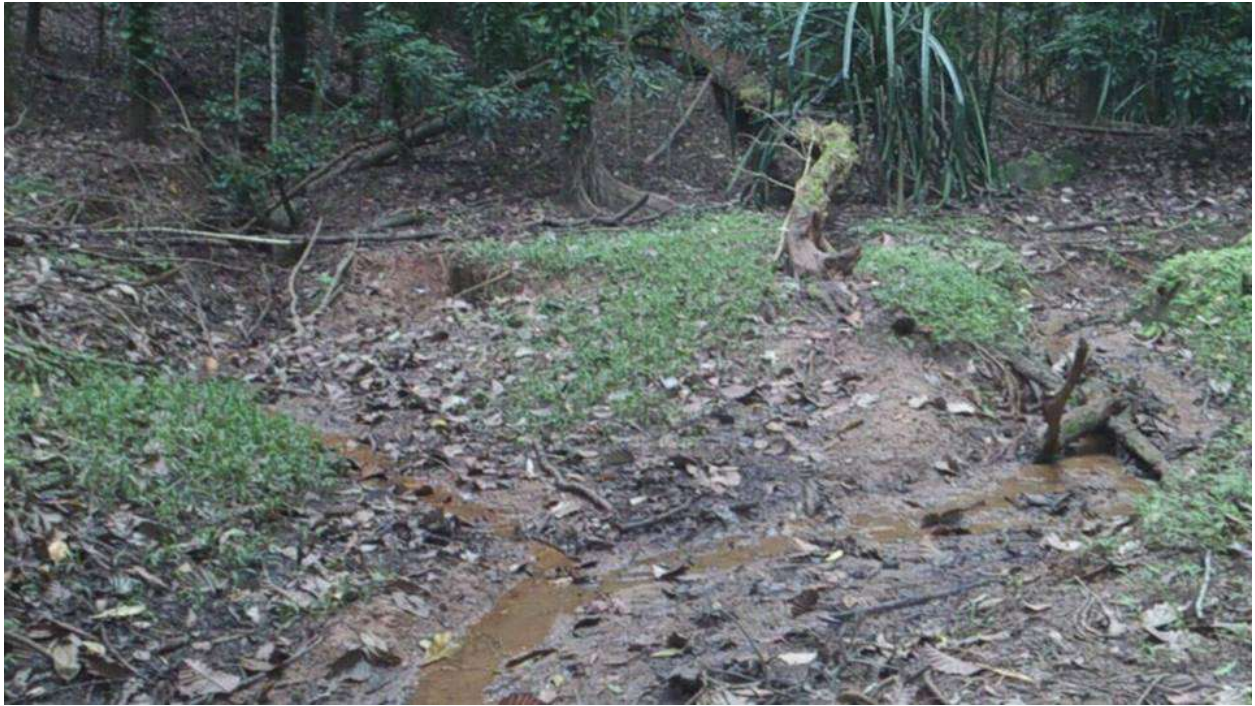
There are two micro catchments and you can see two thalvege lines with two base flows running down towards the pond.

Figure 35: Two streams coming down form two sub catchments or micro catchments in the forest

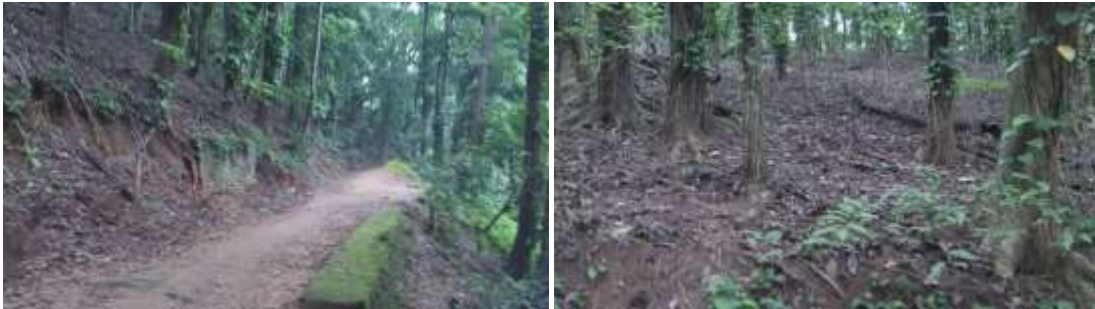
As shown in the Figure 37 (a), access roads have been built for recreational purposes and lots of ground cover is been removed Figure 37 (b). This is the main cause for the siltation of the royal pond.

Figure 37: Road construction and removal of ground cover in upper catchment areas

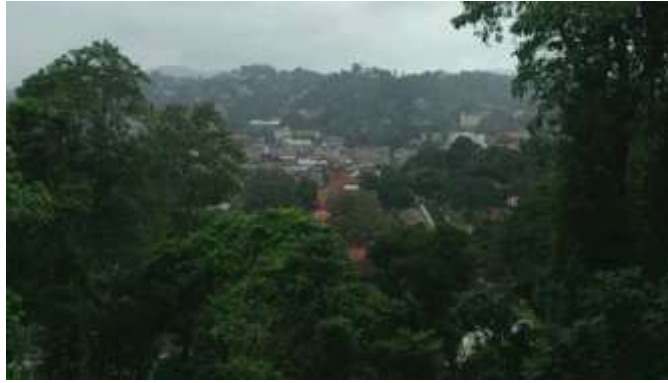
Figure 39: Kandy city from the Udawatta forest reserve

Figure 39 and 40 shows the population pressure and the environmental degradation happening in the evergreen forests in Sri Lanka. Figure 41 shows the abandoned fertile lands in the dry zone areas. Segiriya could be identified as a model of water kingdom which was badly neglected and now we are experiencing consequences.

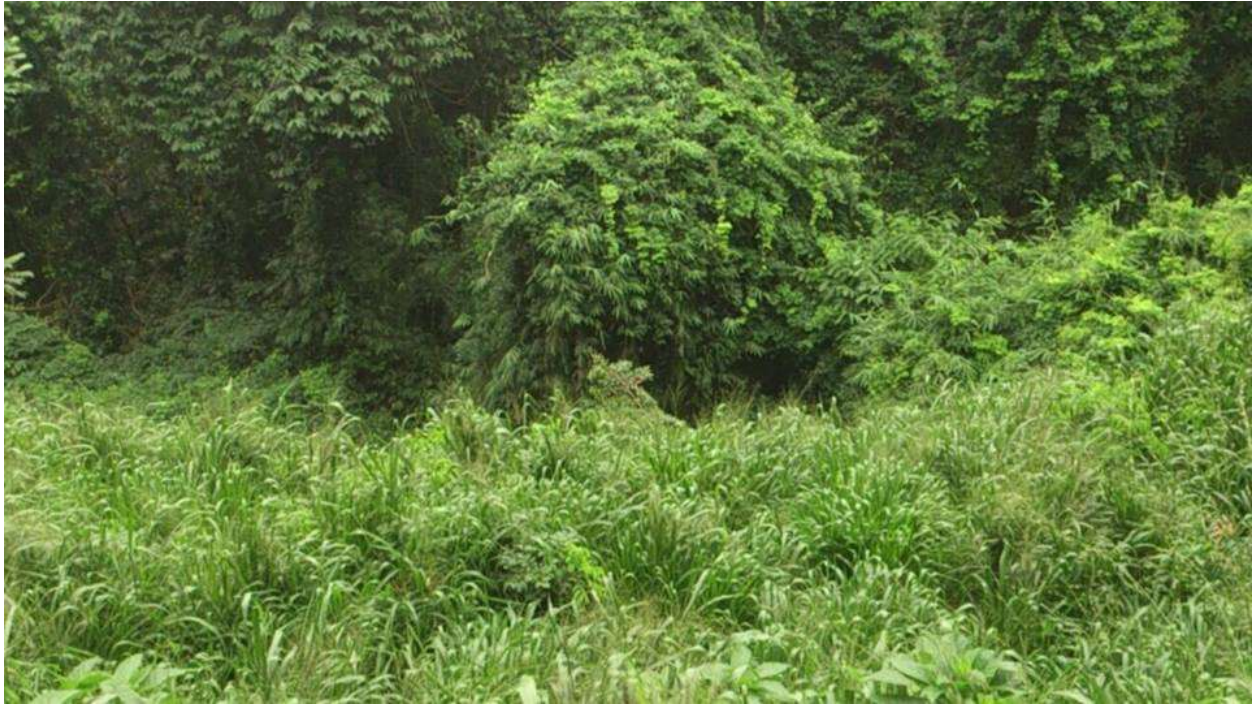
Figure 42, shows the stream running towards the Kandy Lake from the Udawatta Forest area. It is another micro catchment belongs to the forest. Fortunately it is covered with the stream bank vegetation and may be filtering derbies and silt coming from uplands.

Figure 42: Stream running down from the Udawatta forest to the Kandy Lake
